Special Report 80-32

CHARACTERISTICS OF ICE IN WHITEFISH BAY AND ST. MARYS RIVER DURING JANUARY, FEBRUARY AND MARCH 1979

Prepared for
RESEARCH AND DEVELOPMENT CENTER
U.S. COAST GUARD

UNITED STATES ARMY
CORPS OF ENGINEERS
COLD REGIONS RESEARCH AND ENGINEERING LABORATORY
HANOVER, NEW HAMPSHIRE, U.S.A.

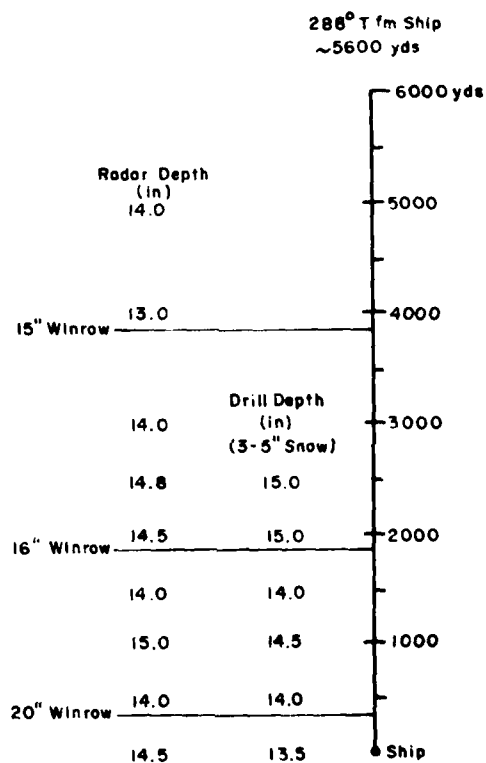
Figure A1. Run 1 radar comparison,
31 January 79.

At several sites during the early stages of the test program, an impulse radar was utilized to determine the continuous profile of the ice sheet and the brash thickness. In all cases, the radar readings were within ± 2 in. of the physical measurements.

Thickness profiles are presented in Appendix Figures A1-A12. The thickness between data points may not be exactly as depicted in the profiles but will lie between the maximum and minimum shown for the particular run. The specific data for each run will be found in Internal Report 628.

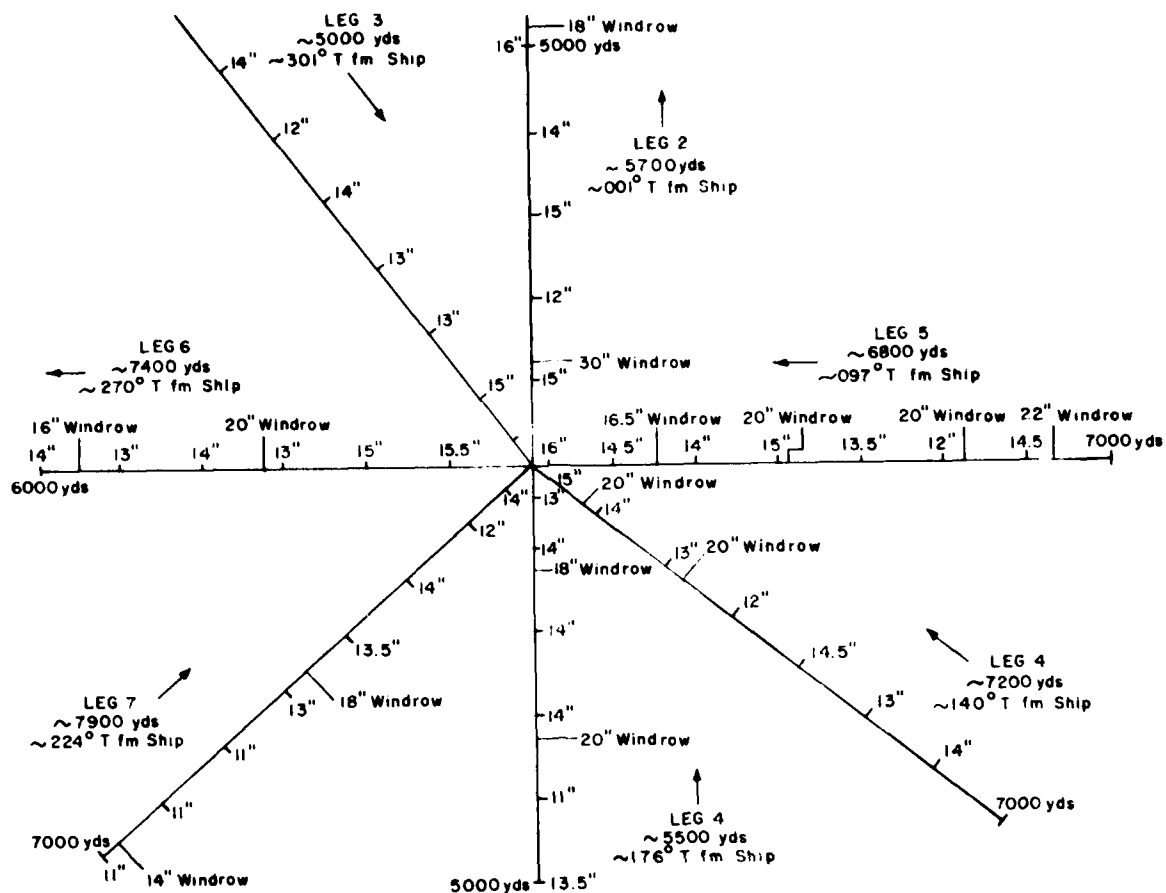
Figure A2. Radar sector survey, 31 January 1979.

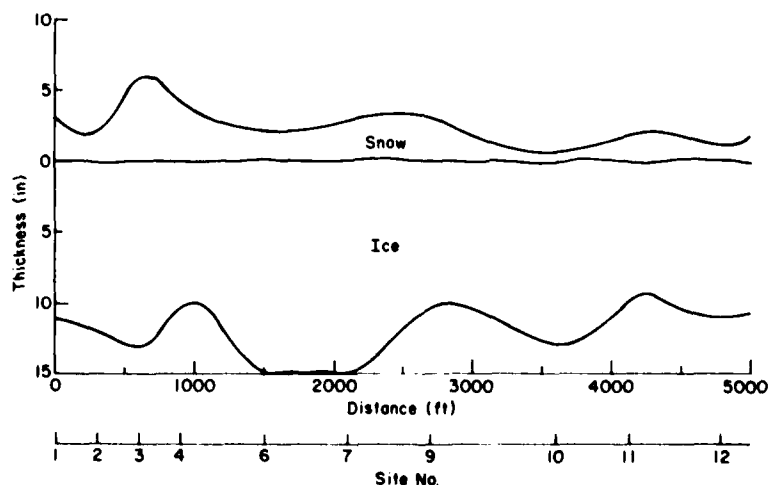
Figure A3. Snow thickness profiles, 30 January 1979.

Snow cover thickness varied greatly due to the wind effect on the snow cover.

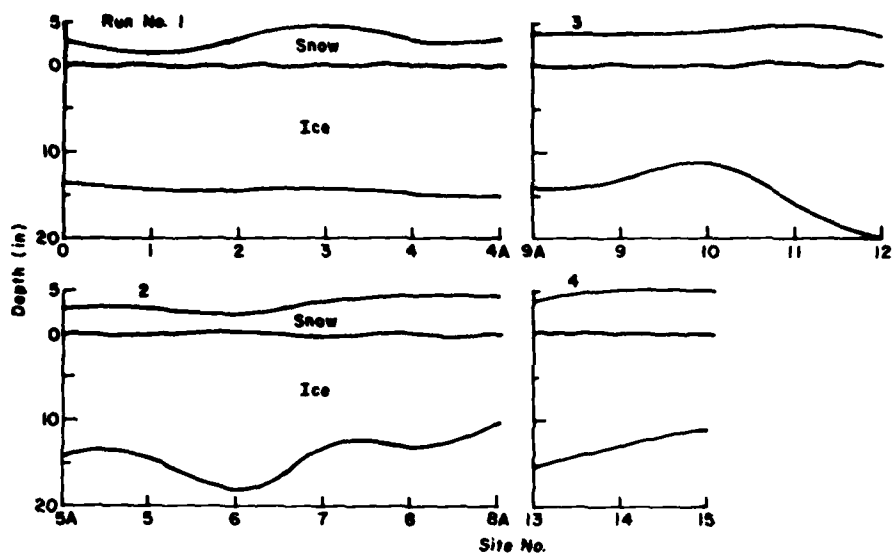
Figure A4. Ice and snow thickness, runs 1-4, 31 January 1979.

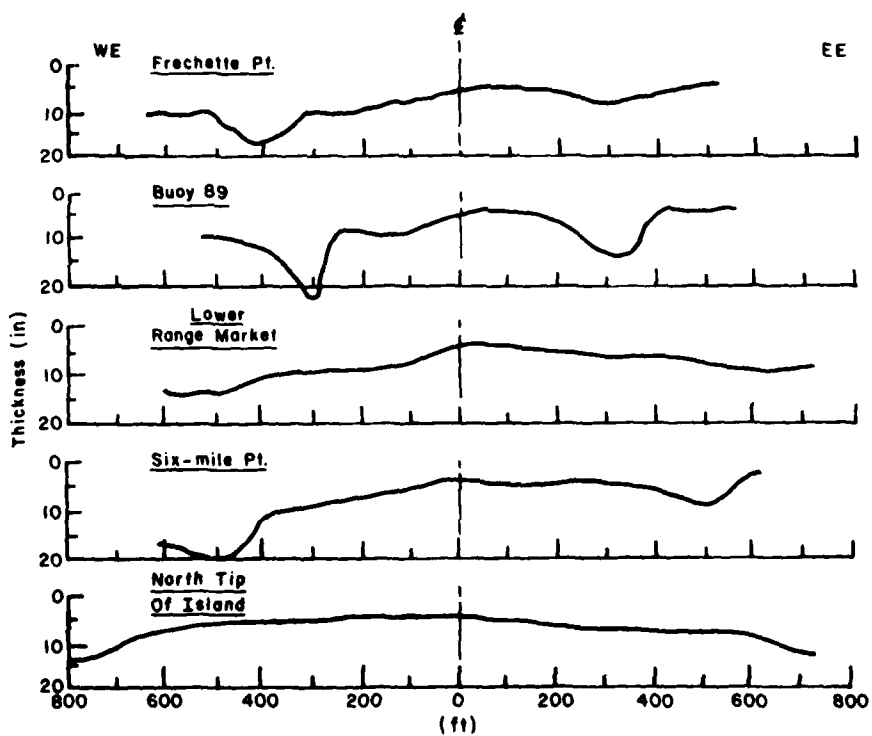
Figure A5. Brash ice in St. Marys River, 31 January 1979.

The brash ice thickness was a function of the frequency of ship passage, location and time. The variations in brash ice thickness were much greater than those of the plate ice.

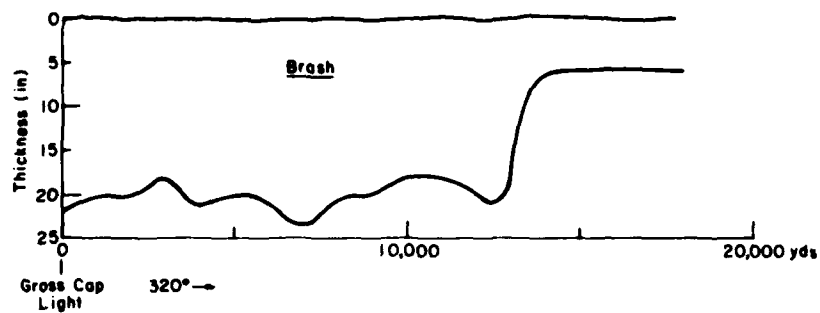
Figure A6. Brash ice thickness, 1 February 1979.

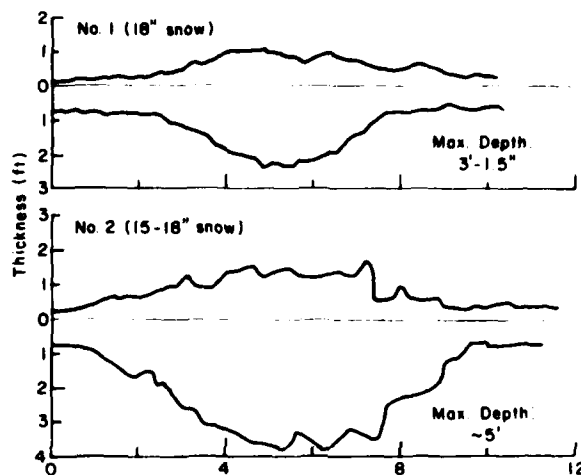
Figure A7. Pressure ridges in Whitefish Bay, 1 February 1979.

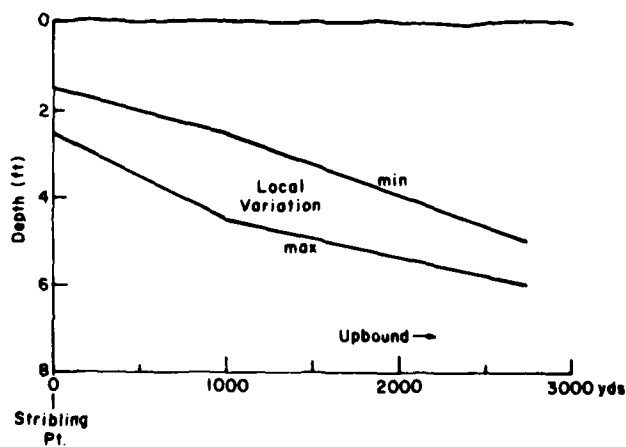
Figure A8. Brash ice thickness, 8 February 1979.

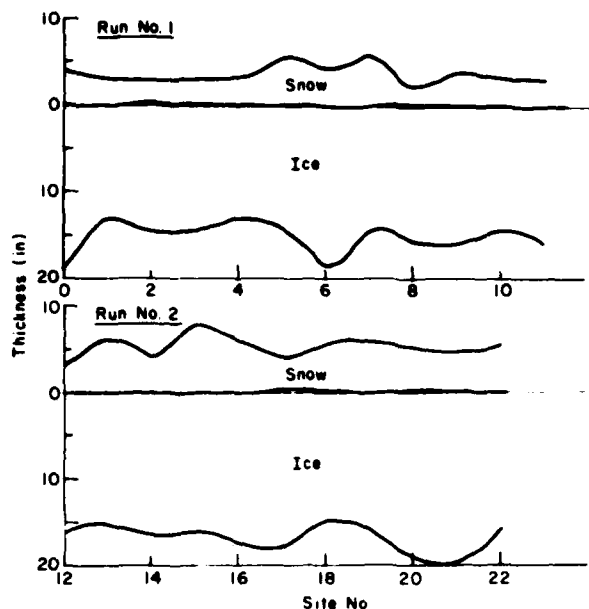
Figure A9. Ice and snow thickness, 9 February 1979.

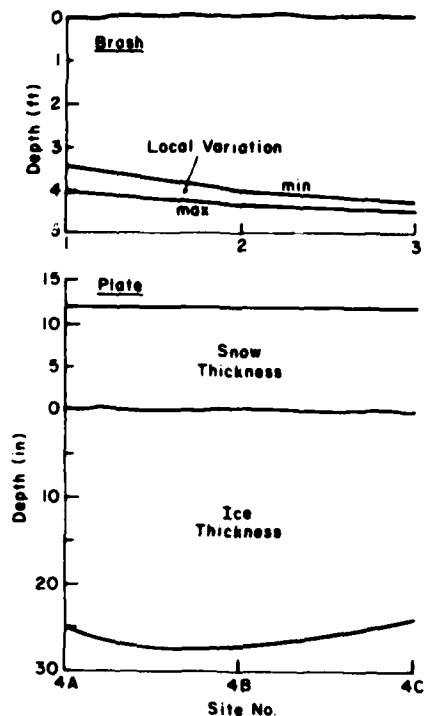
Figure A10. Brash and plate ice thickness, St. Marys River, 10 February 1979.

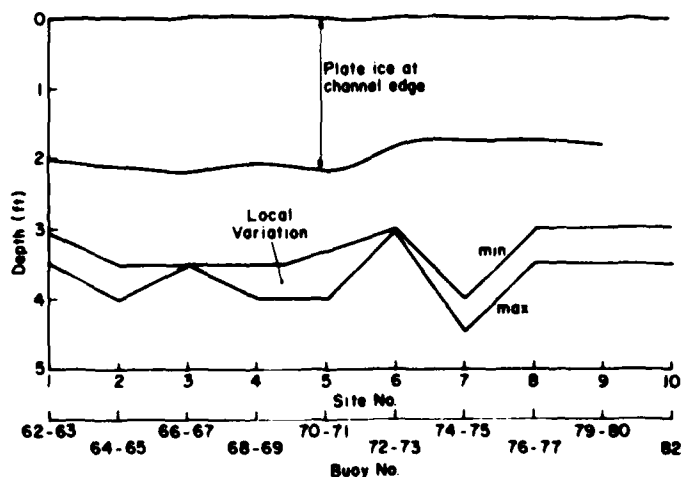
Figure A11. Brash ice thickness, 8 February 1979.

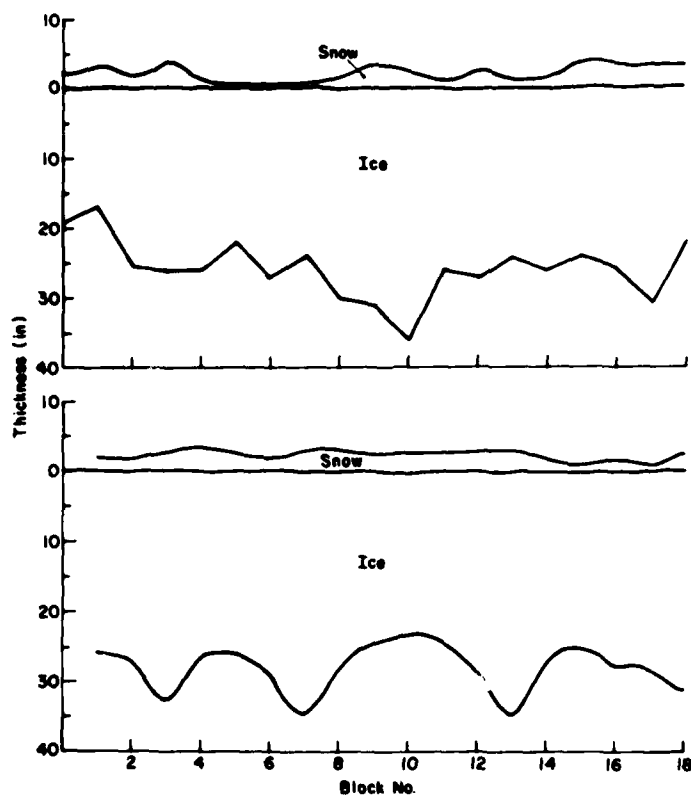
Figure A12. Ice and snow thickness for two runs, 9 February 1979.

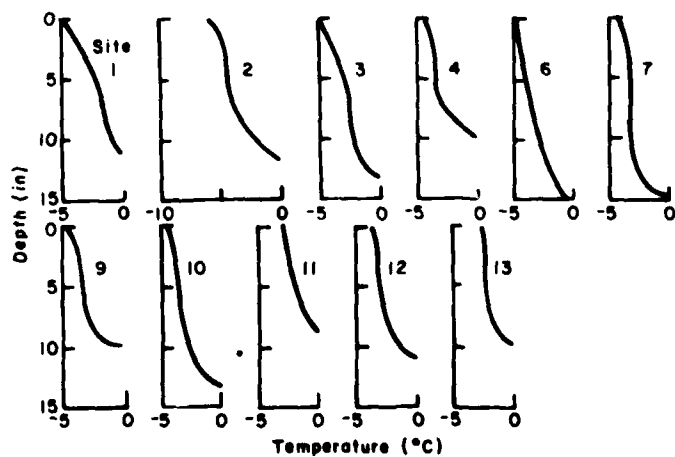
Figure A13. Temperature profiles for Whitefish Bay, 30 January 1979.

Temperature profiles (Fig. A13-A17) were taken in all the plate ice in which the vessel was tested. Profiles were also taken in the plate ice adjacent to the channels in which the brash ice tests were conducted.

The temperature profiles were obtained by drilling into the ice with a 1.5-in. drill and inserting a thermistor (which read out directly on a bridge calibrated in degrees Celsius) in the hole until it made contact with the ice surface. Extreme care was taken to ensure that all snow and loose ice chips were removed from the hole when the temperature measurements were taken.

Ice temperatures during the early phase of the tests, i.e. January and February 1979, were much lower (-5° to -10°C) than those measured

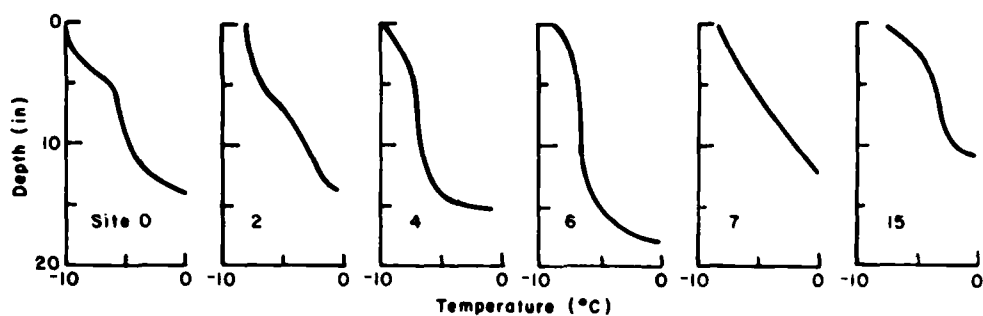
Figure A14. Temperature profiles for Whitefish Bay, 31 January 1979.

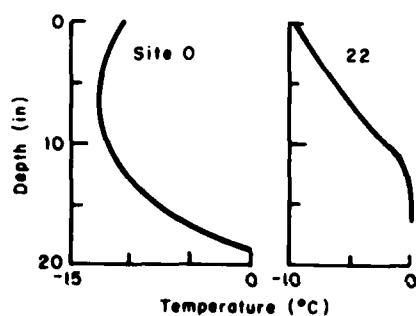
Figure A15. Temperature profiles for Whitefish Bay, 9 February 1979.

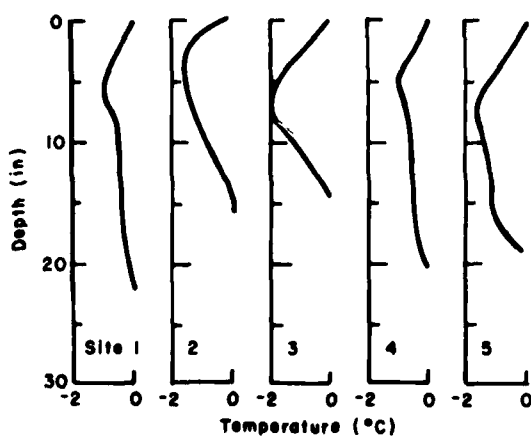
Figure A16. Temperature profiles for plate ice at edge of channel in St. Marys River, 13 March 1979.

during the March test (i.e. 0° to -3°C). In fact, some of the ice temperatures during March were so close to 0°C that it was difficult to observe any reading on the thermistor bridge.

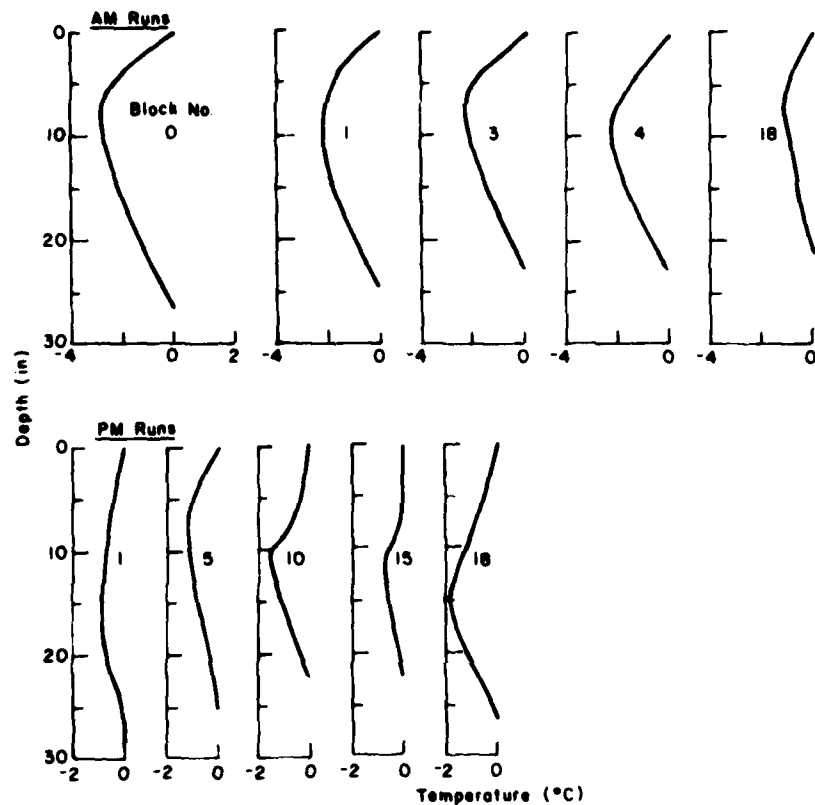
Figure A17. Temperature profiles for AM and PM runs in Whitefish Bay, 17 March 1979.

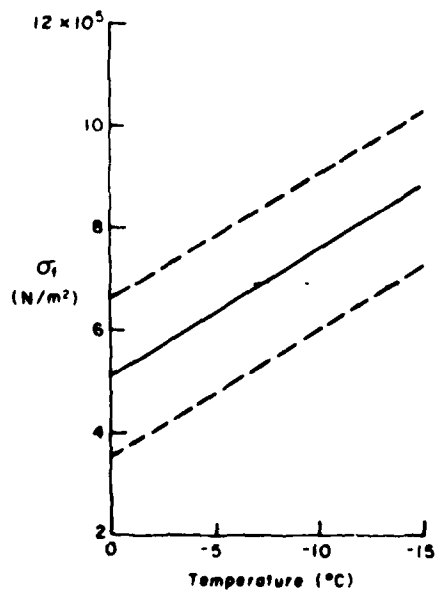
Figure A18. Freshwater ice flexural strength vs temperature.

The enclosed graphs (Fig. A18-A21) summarize the results of the efforts of many researchers (Butyagin 1972, Frankenstein 1961, Gow et al. 1978, Hawkes and Mellor 1972, and Lavrov 1969) over many years. The standard deviation indicates the diversity of test results due to different test conditions and techniques. In addition, the results are not as linear as indicated in these summary curves, particularly as the melting point is approached.

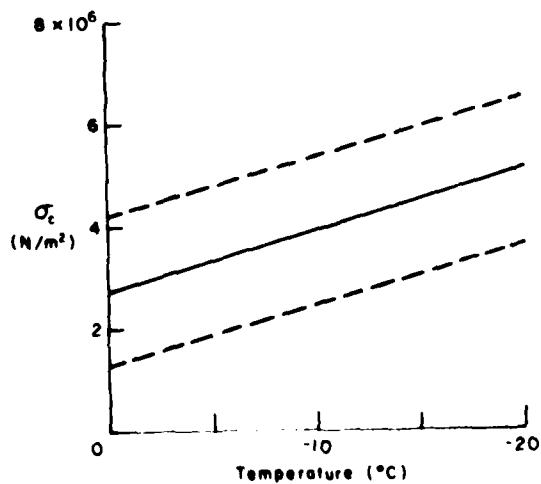
Figure A19. Freshwater ice compressive strength vs temperature.

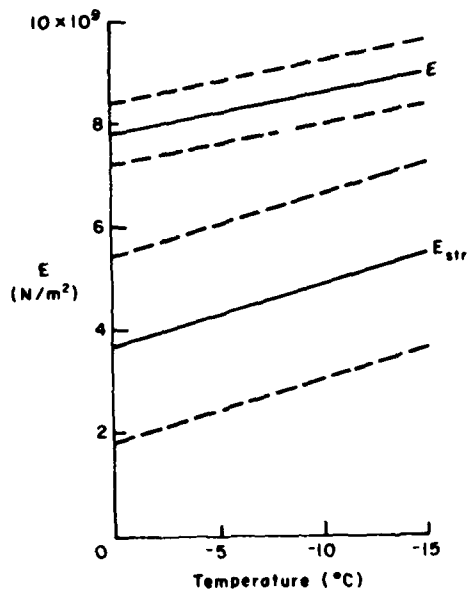
Figure A20. Freshwater ice dynamic and strain modulus of elasticity vs temperature.

There are two curves (Fig. A20 and A21) presented for the elastic modulus E of freshwater ice. The higher values of E are obtained using acoustic techniques and represent the ideal or linear portion of the stress-strain curve. The lower curve labeled E_{str} is referred to as a strain modulus and is determined by field and laboratory work in beam bending and sheet deflection. It represents the portion of the stress strain curve that incorporates elastic and plastic deformation.

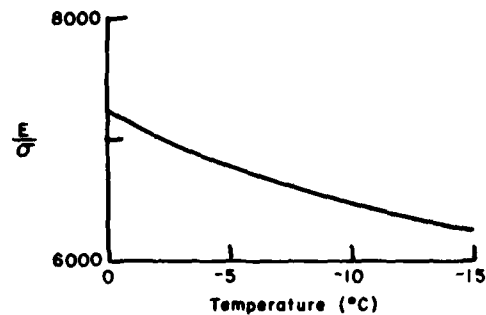
Figure A21. E/σ vs temperature.

The E_{str}/σ_f ratio varied between 6250 and 7250, increasing as the temperature increased. The density of the ice and snow and salinity of the ice was in the range expected.

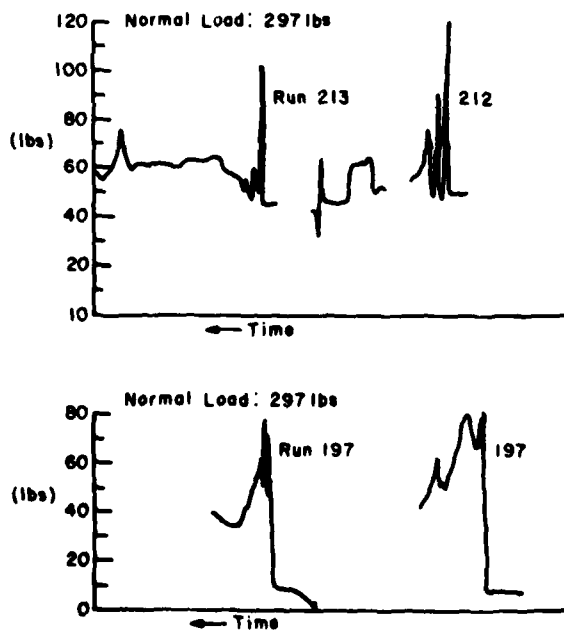
Figure A22. Typical records of ice-steel friction force for four runs.

The friction tests were conducted by loading a 1-ft³ ice block with 25-lb lead weights such that the normal load could be varied from the weight of the ice block and towing cage to approximately 500 lb. The towing speed was varied by either pulling the block and weights with a small winch or a screw jack. The winch, being a more elastic system, experienced stick-slip phenomena, which made it slightly more difficult to determine a mean value. The jack provided a smoother pulling force but its speed (0.225 ft/sec) was less than half that of the winch (0.52 ft/sec).

The normal force was determined by weighing the ice block, towing harness and weights. The tangential force was obtained with a load cell positioned between the towing harness and the winch cable or jack screw. The tangential force was recorded on a Hewlett-Packard recorder. Typical recorder records are shown in Figures A22 and A23. A summary of all friction tests records is contained in Internal Report 628.

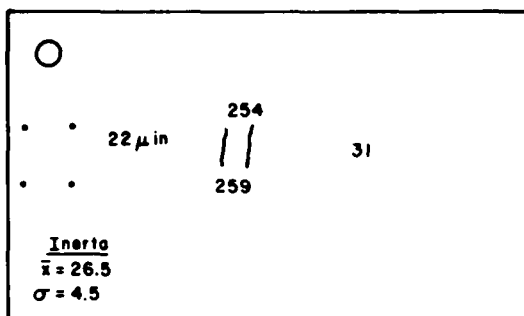
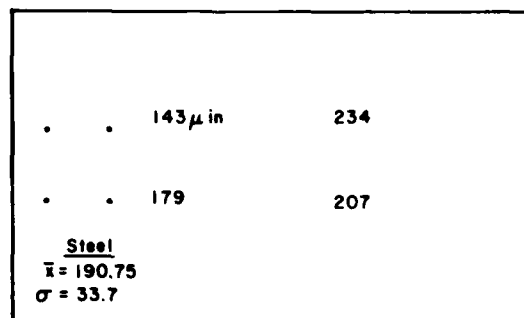
Figure A24. Roughness measurements.

a. Inerta-coated plate,
10 February 1979.

b. Uncoated steel plate,
12 February 1979.

The roughness of the plates utilized is delineated in Figures A24-A26. The roughness was determined using a Surtronic 3 surface profilometer, with three readings at each point being averaged.

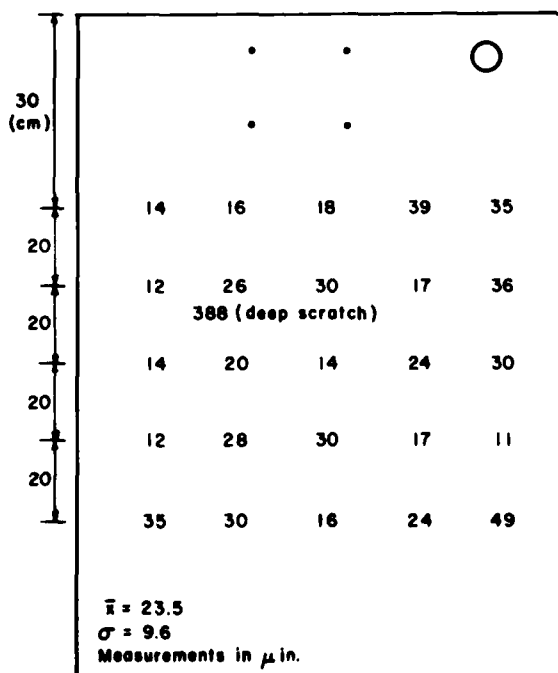
Figure A25. Roughness measurements on
Inerta plate, 16 March 1979.

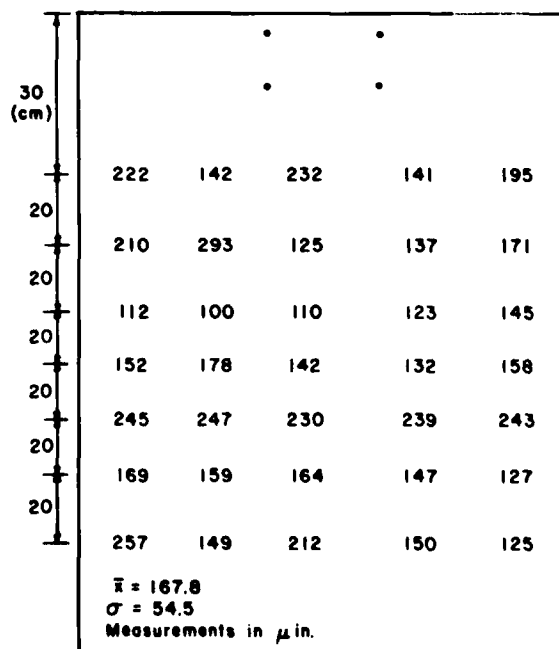
Figure A26. Roughness measurements on steel
plate, 15 March 1979.

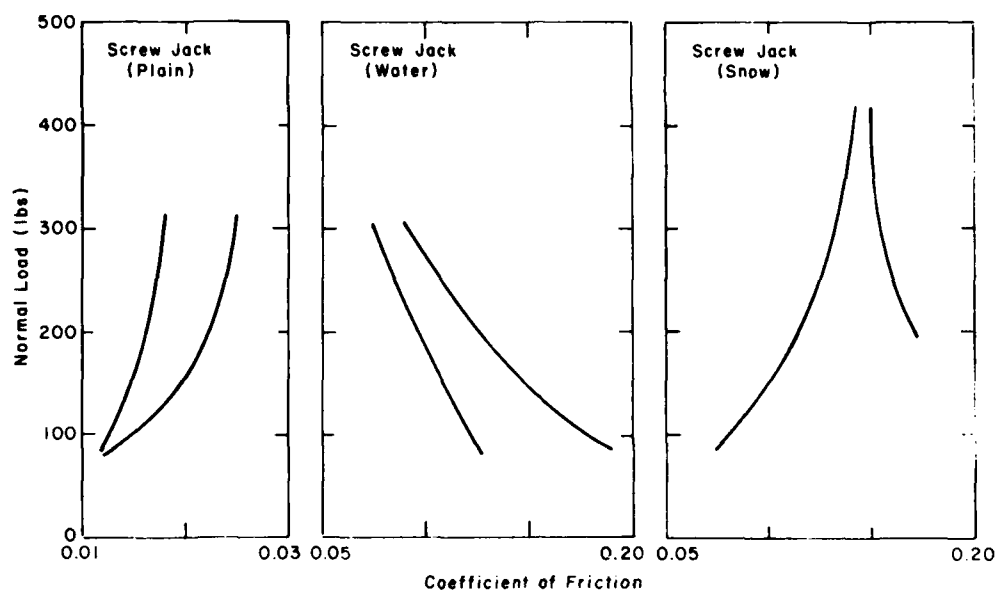
Figure A27. Dynamic coefficient of friction vs normal load for Inerta 160, 12 February 1979.

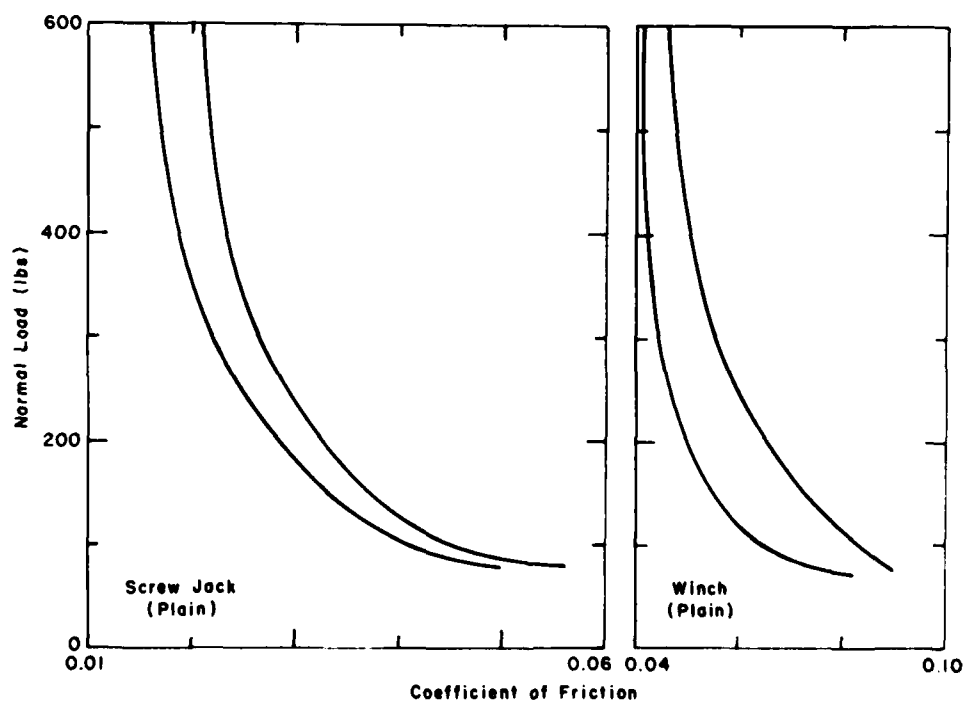
Figure A28. Dynamic coefficient of friction vs normal load for Inerta 160, 10 February 1979.

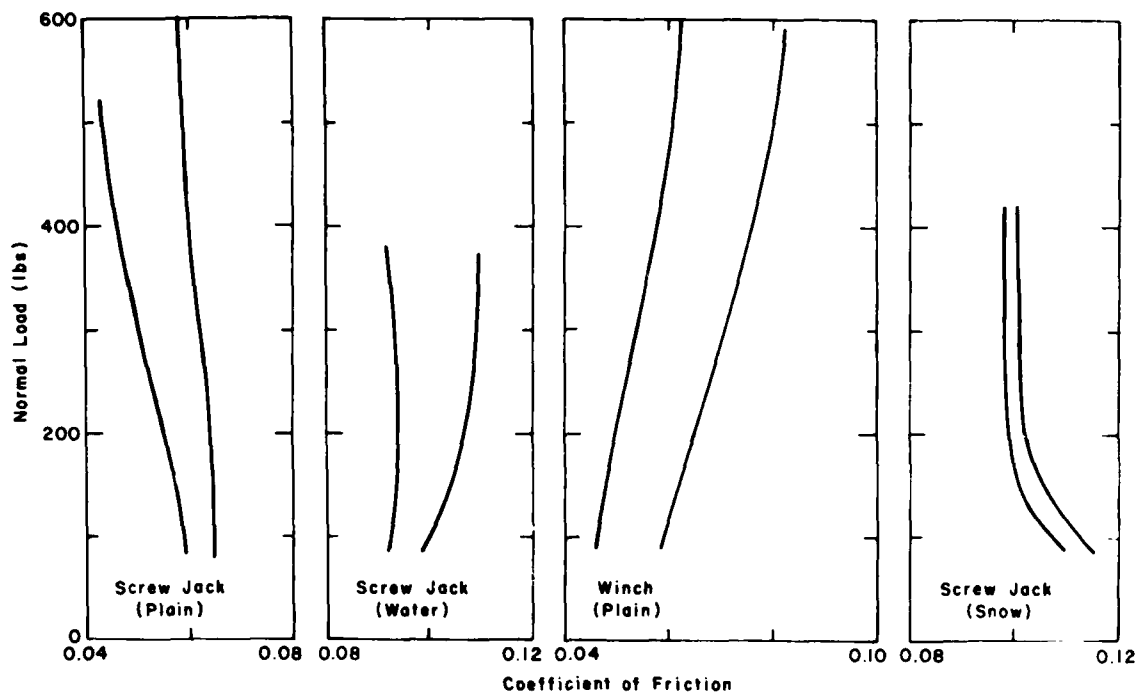
Figure A29. Dynamic coefficient of friction vs normal load for uncoated steel plate, 12 February 1979.

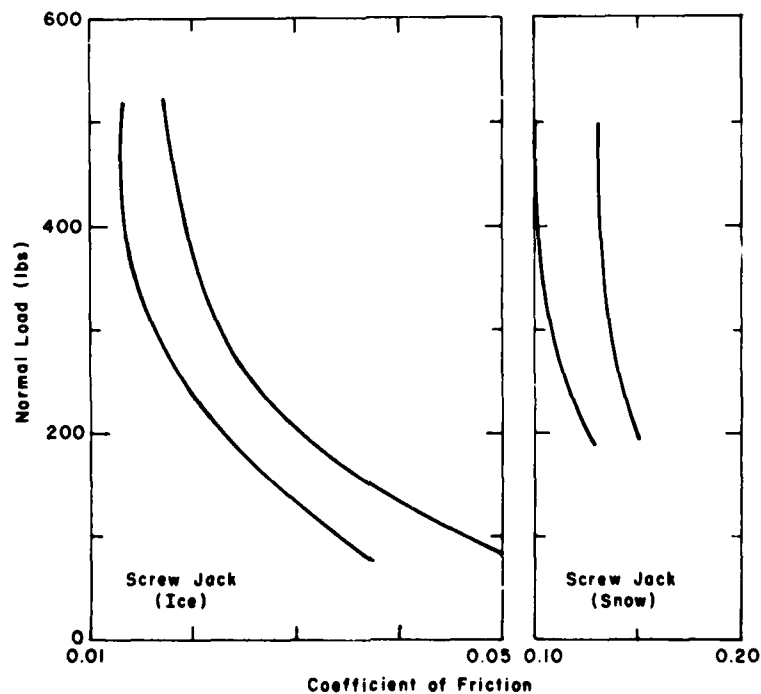
Figure A30. Dynamic coefficient of friction vs normal load for uncoated steel plate measured with screw jack, 15 March 1979.

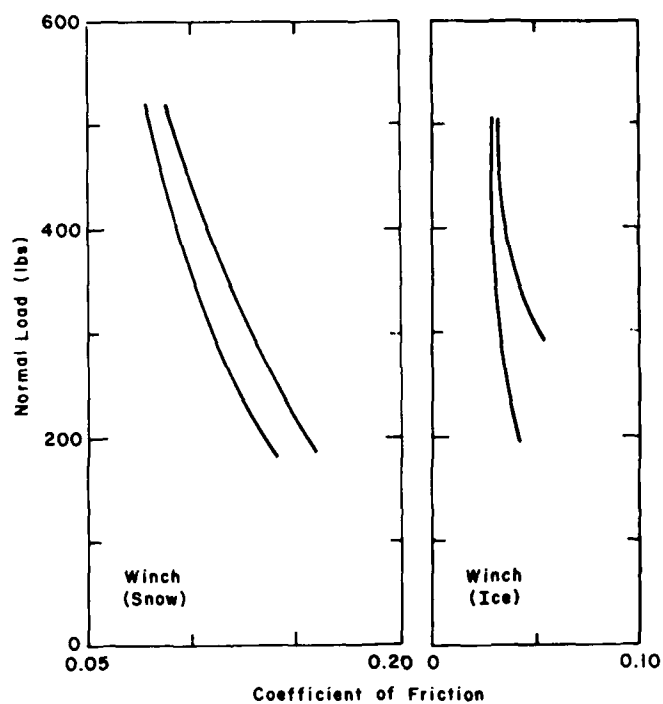
Figure A31. Dynamic coefficient of friction vs normal load with winch for Inerta 160, 15 March 1979.

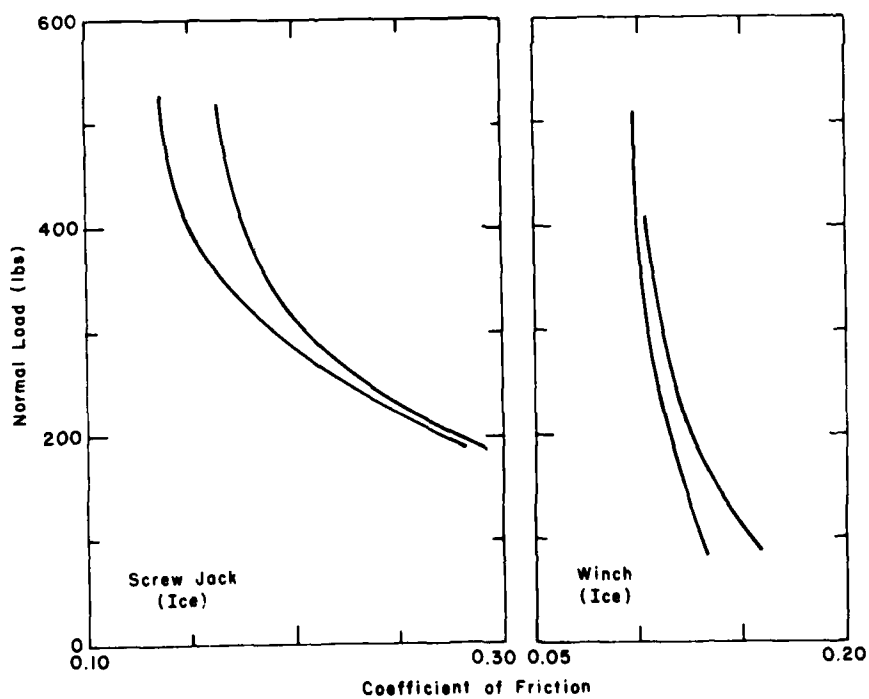
Figure A32. Dynamic coefficient of friction vs normal load for steel plate and ice, 15 March 1979.

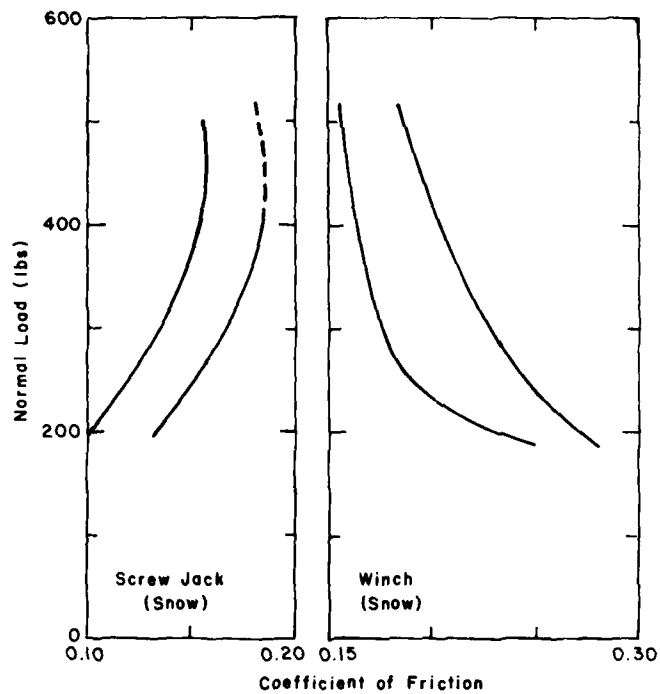
Figure A33. Dynamic coefficient of friction vs normal load for steel plate and snow, 15 March 1979.

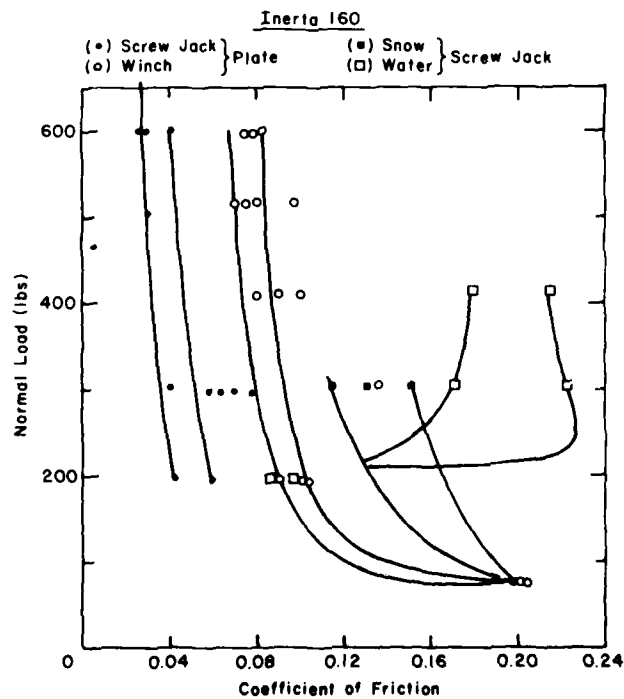
Figure A34. Static coefficient of friction vs normal load for Inertia 160, 10 and 12 February 1979.

The static coefficient of friction was some two to five times higher than the dynamic coefficient, varying from 0.037 to 0.48.

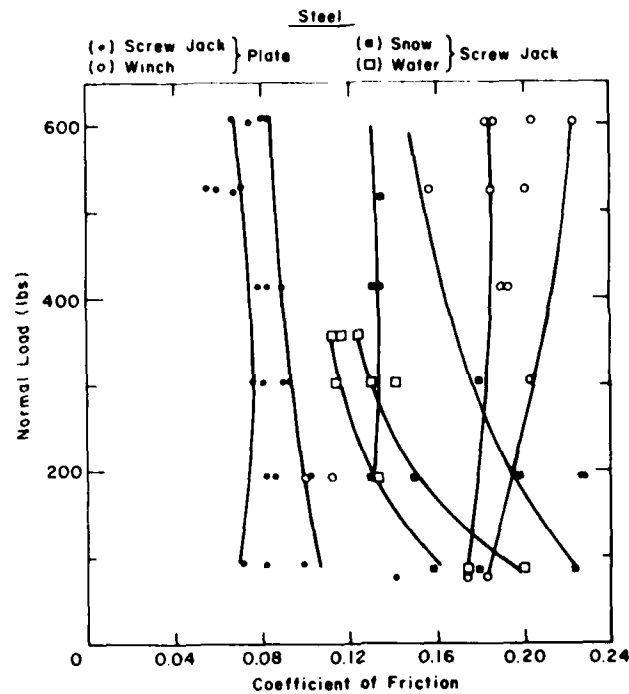
Figure A35. Static coefficient of friction vs normal load for steel plate, 10 and 12 February 1979.

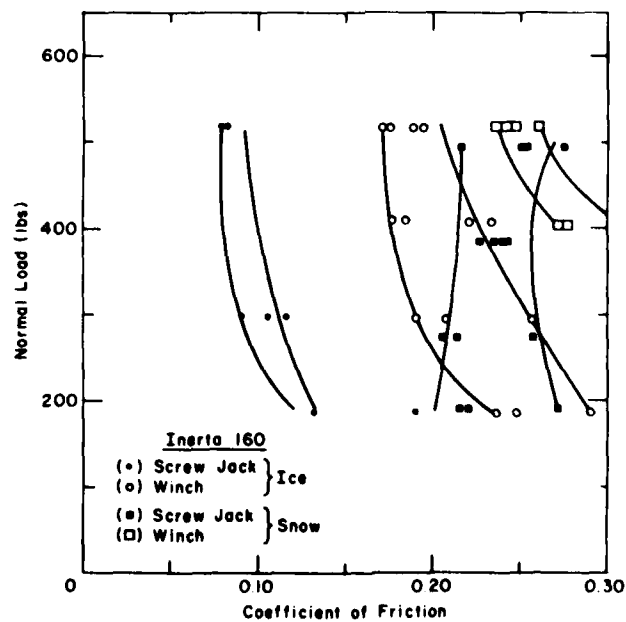
Figure A36. Static coefficient of friction vs normal load for Inerta 160, 15-16 March 1979.

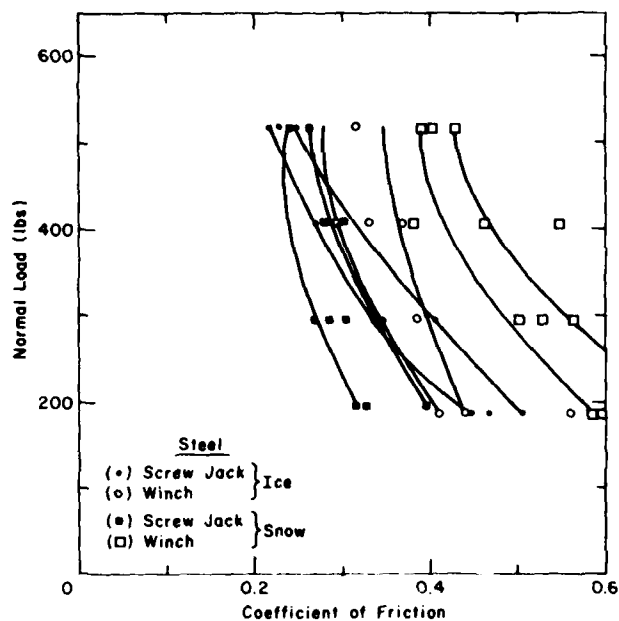
Figure A37. Static coefficient of friction vs normal load for steel plate, 15-16 March 1979.

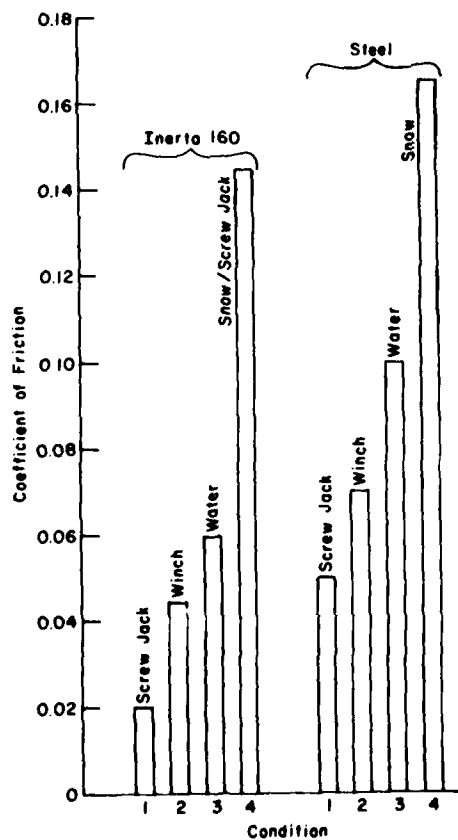
Figure A38. Dynamic tests, 10 and 12 February ($V_w = 0.52$ ft/sec, $V_{ss} = 0.225$ ft/sec).

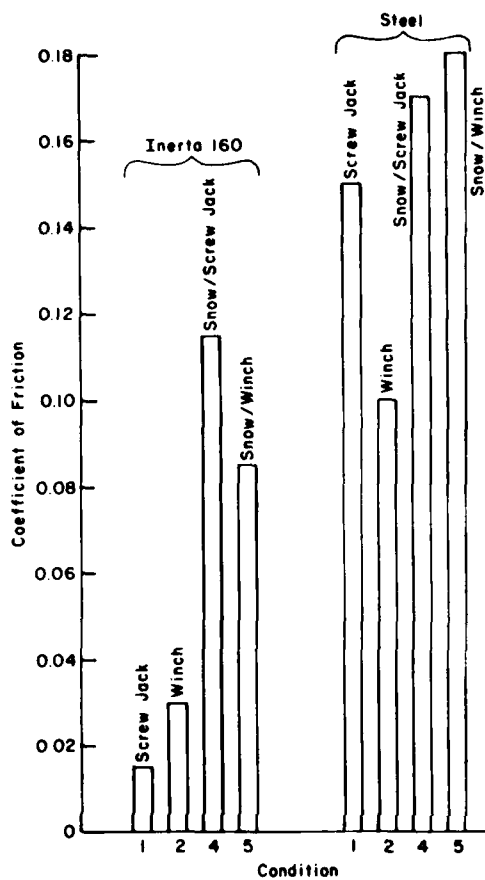
Figure A39. Dynamic tests, 15-16 March 1979.

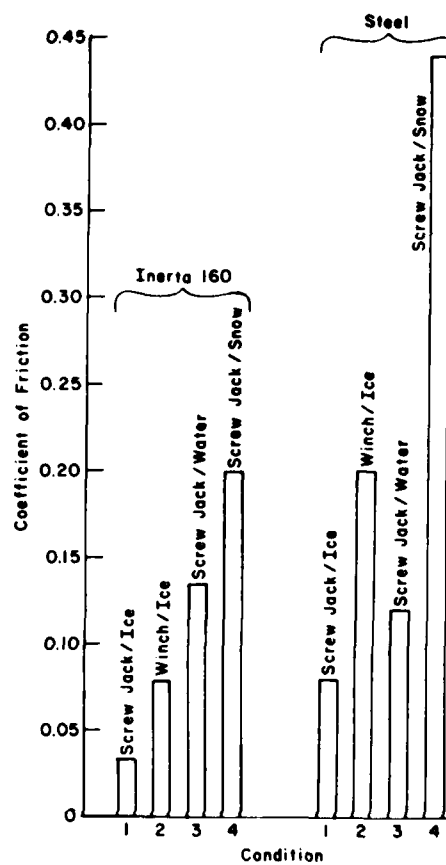
Figure A40. Static tests, 10 and 12 February 1979.

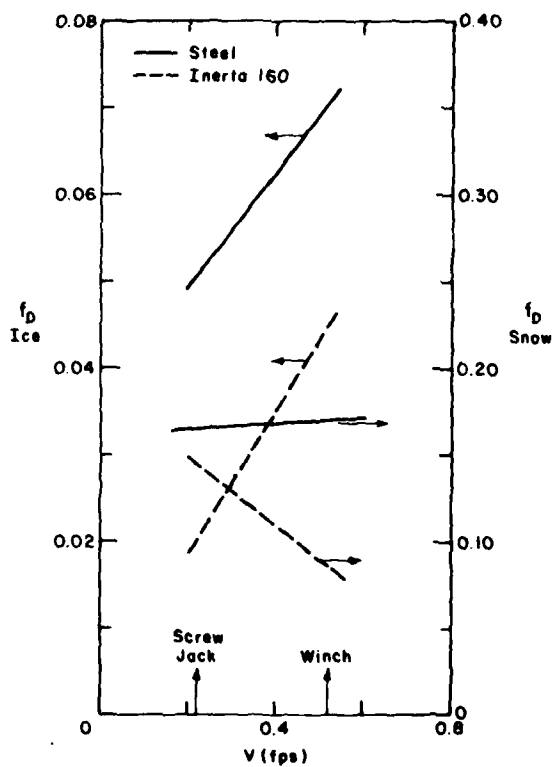
Figure A42. Dynamic coefficient of friction vs speed.

The two towing speeds utilized were 0.31 knots (0.52 ft/sec) and 0.132 knots (0.225 ft/sec), and the trend indicates an increase in friction coefficient with speed except for the Inerta-snow-winch combination.
